# AVRO VULCAN

1952 onwards (B2 model)

## Owners' Workshop Manual

An insight into owning, restoring, servicing and flying  
Britain's legendary Cold War bomber

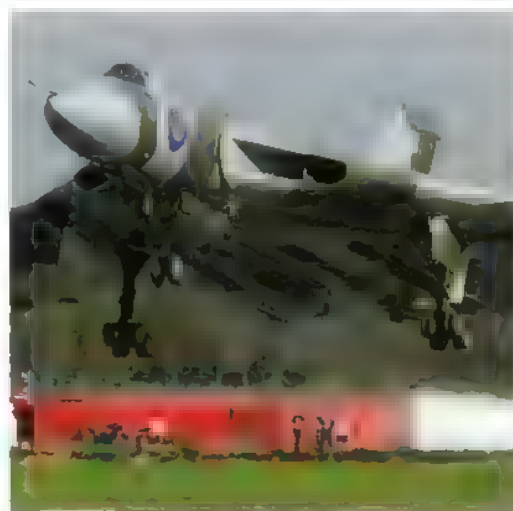
RIGHT Engine intakes. Subliminal advertising on one of the engine blanks carries the plaintive note 'Don't let me die, I want to fly'. Vulcan to the Sky Trust/ Steve Rendle

the engine air intakes, large 'letter box' air inlets situated in each wing root leading edge. The engines are located side-by-side in pairs, two to port and two to starboard, outboard of

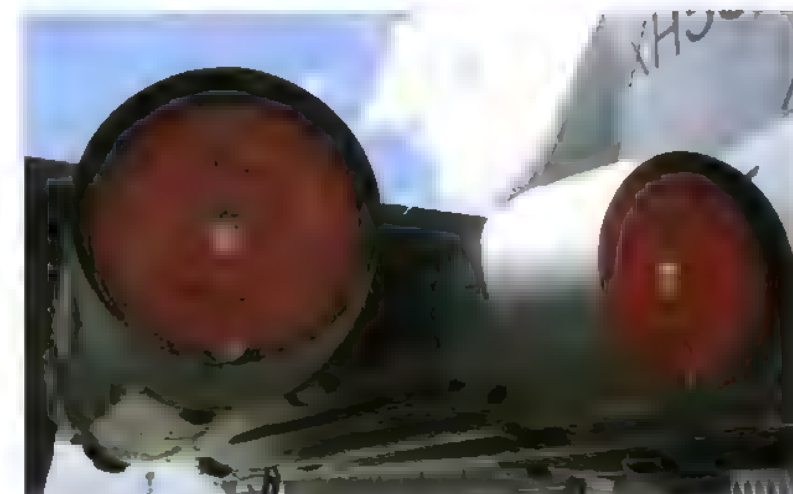
TOP LEFT AND RIGHT Rear fuselage with the engines removed, showing jet pipe tunnels and elevon attachment points. Dave Petrie/ Vulcan to the Sky Trust

The rear section of the fuselage is constructed almost entirely of light alloy pressings and circular formers. This structure provides attachment points for the removable jet pipe end caps. The composite tail cone houses the brake parachute and the electronic jamming equipment.

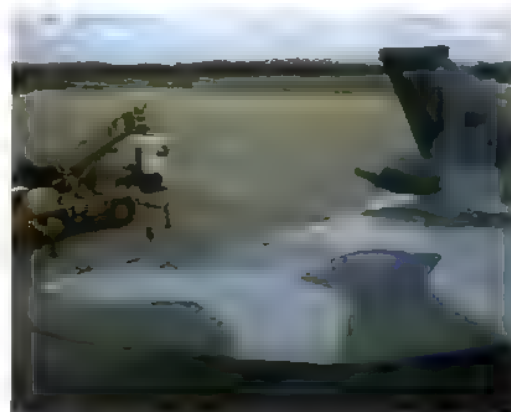
ABOVE Top view of the delta wing showing elevons. Jonathan Falconer

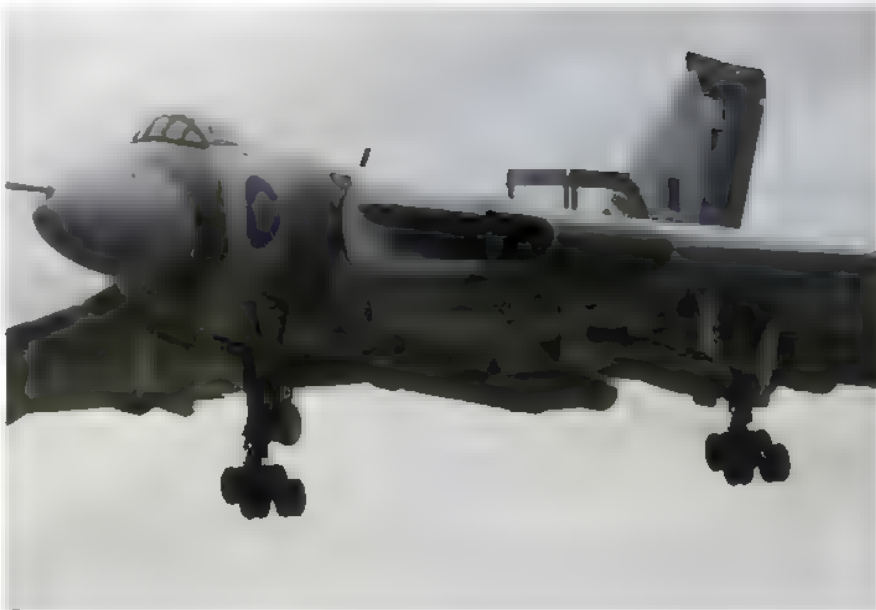
**ABOVE** Air brakes deployed. Damien Burke

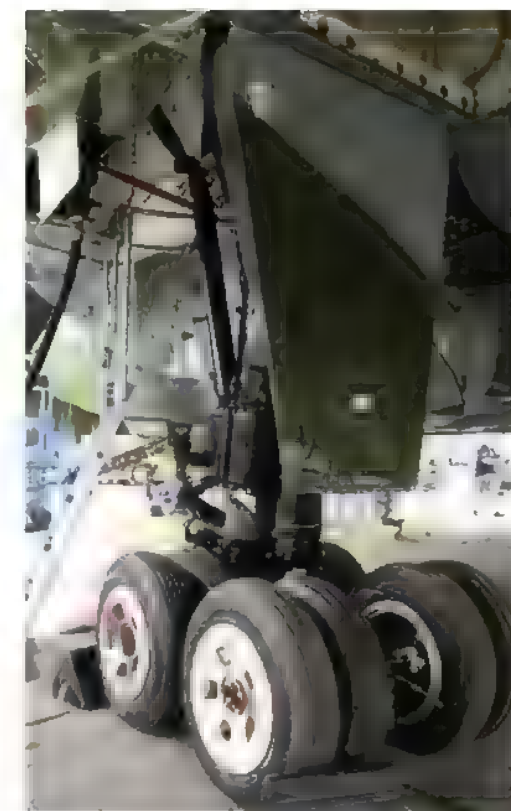
**LEFT** Main gear leg and wheel bogie.

When the main wheel units are fully extended, they are secured in the down position by hydraulically operated down-lock jacks. The nose wheel is locked in the down position by a latch lock, operated when the retraction jack reaches the fully extended position.

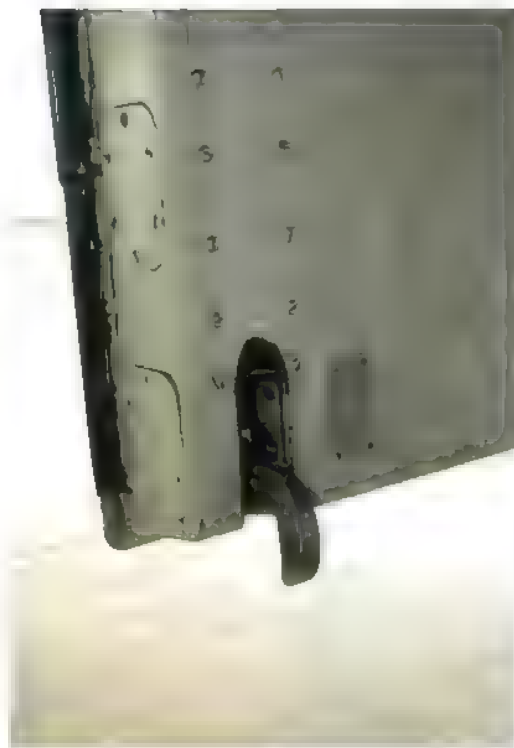
**ABOVE** The robust undercarriage door latch. *Steve Rendle*

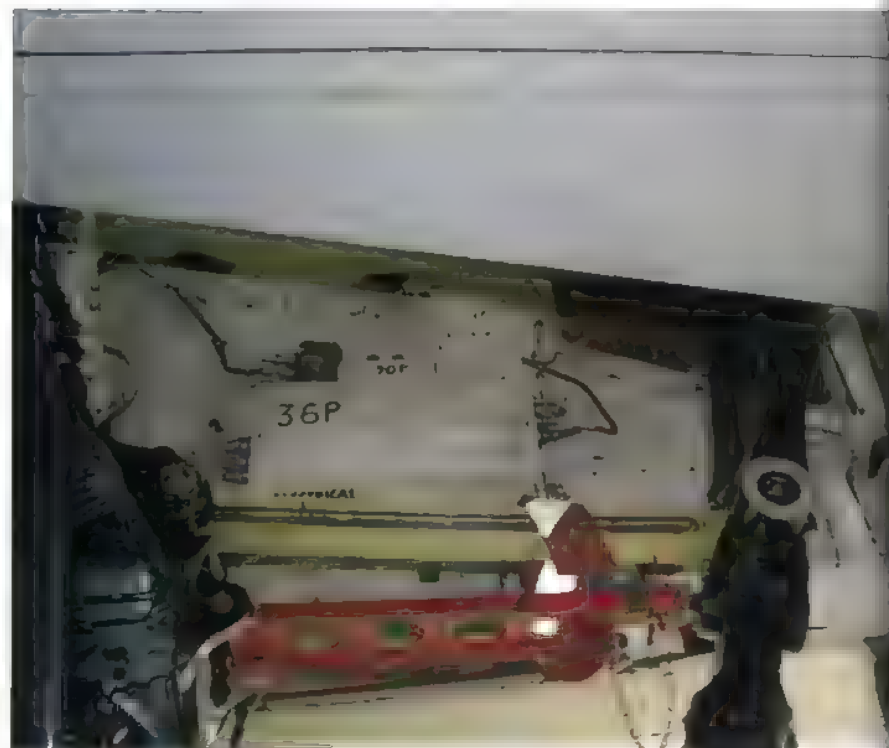
**ABOVE RIGHT** Inside the main undercarriage bay. *Steve Rendle*

When the main wheel units are retracted, the bogies are 'trimmed' so they fit into the wheel bay provided for them in each main plane. The main wheel units are enclosed in their bays by a single fairing door, which is opened and

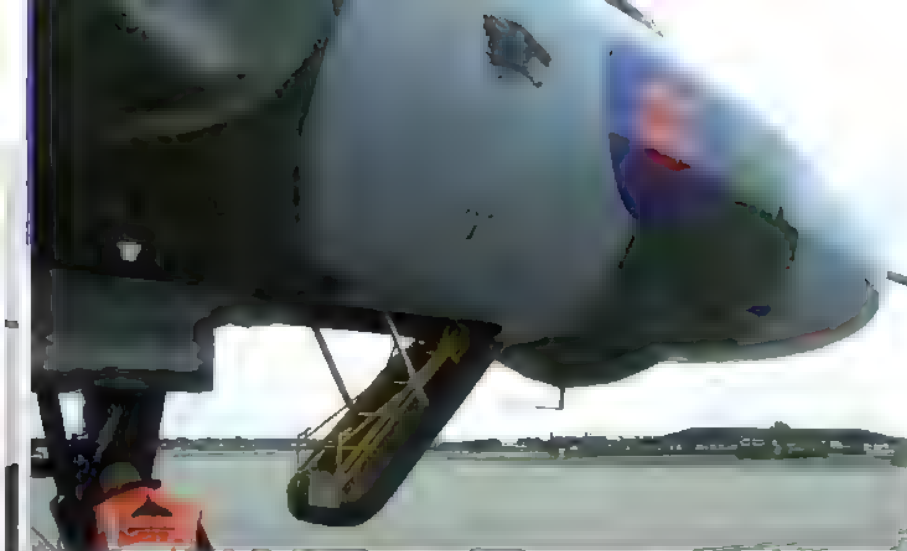
**ABOVE** Access to the Vulcan cockpit was through a downward hinging hatch on the underside of the nose section. Credit?

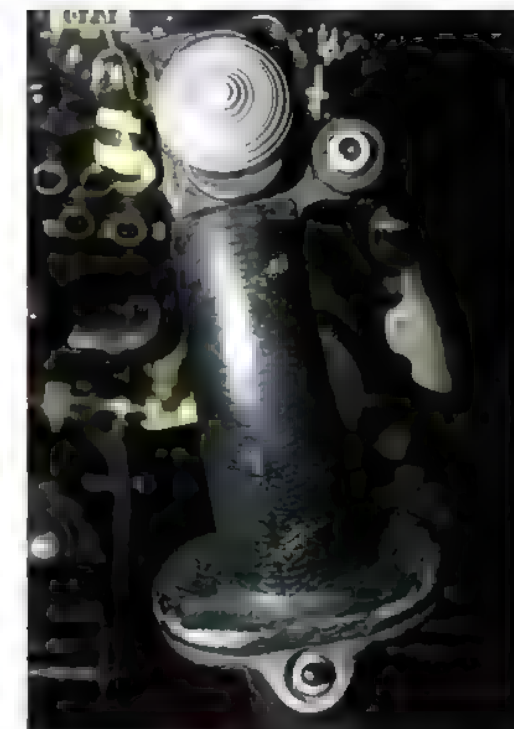
**ABOVE** Control column showing feel relief switch, elevon trimmer, press-to-transmit and nose-wheel steering buttons. *Phil Whalley*

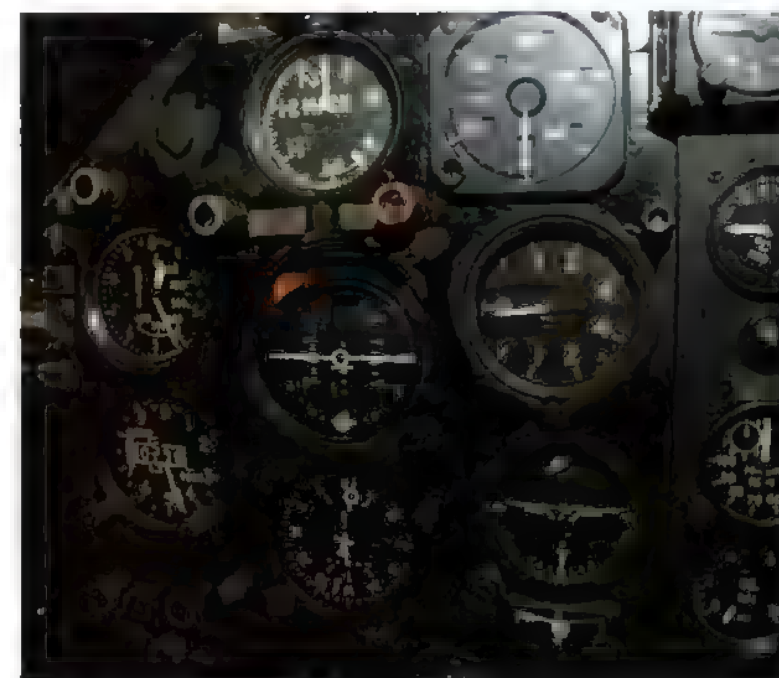
**BELOW** Left hand instrument panel. *Phil Whalley*

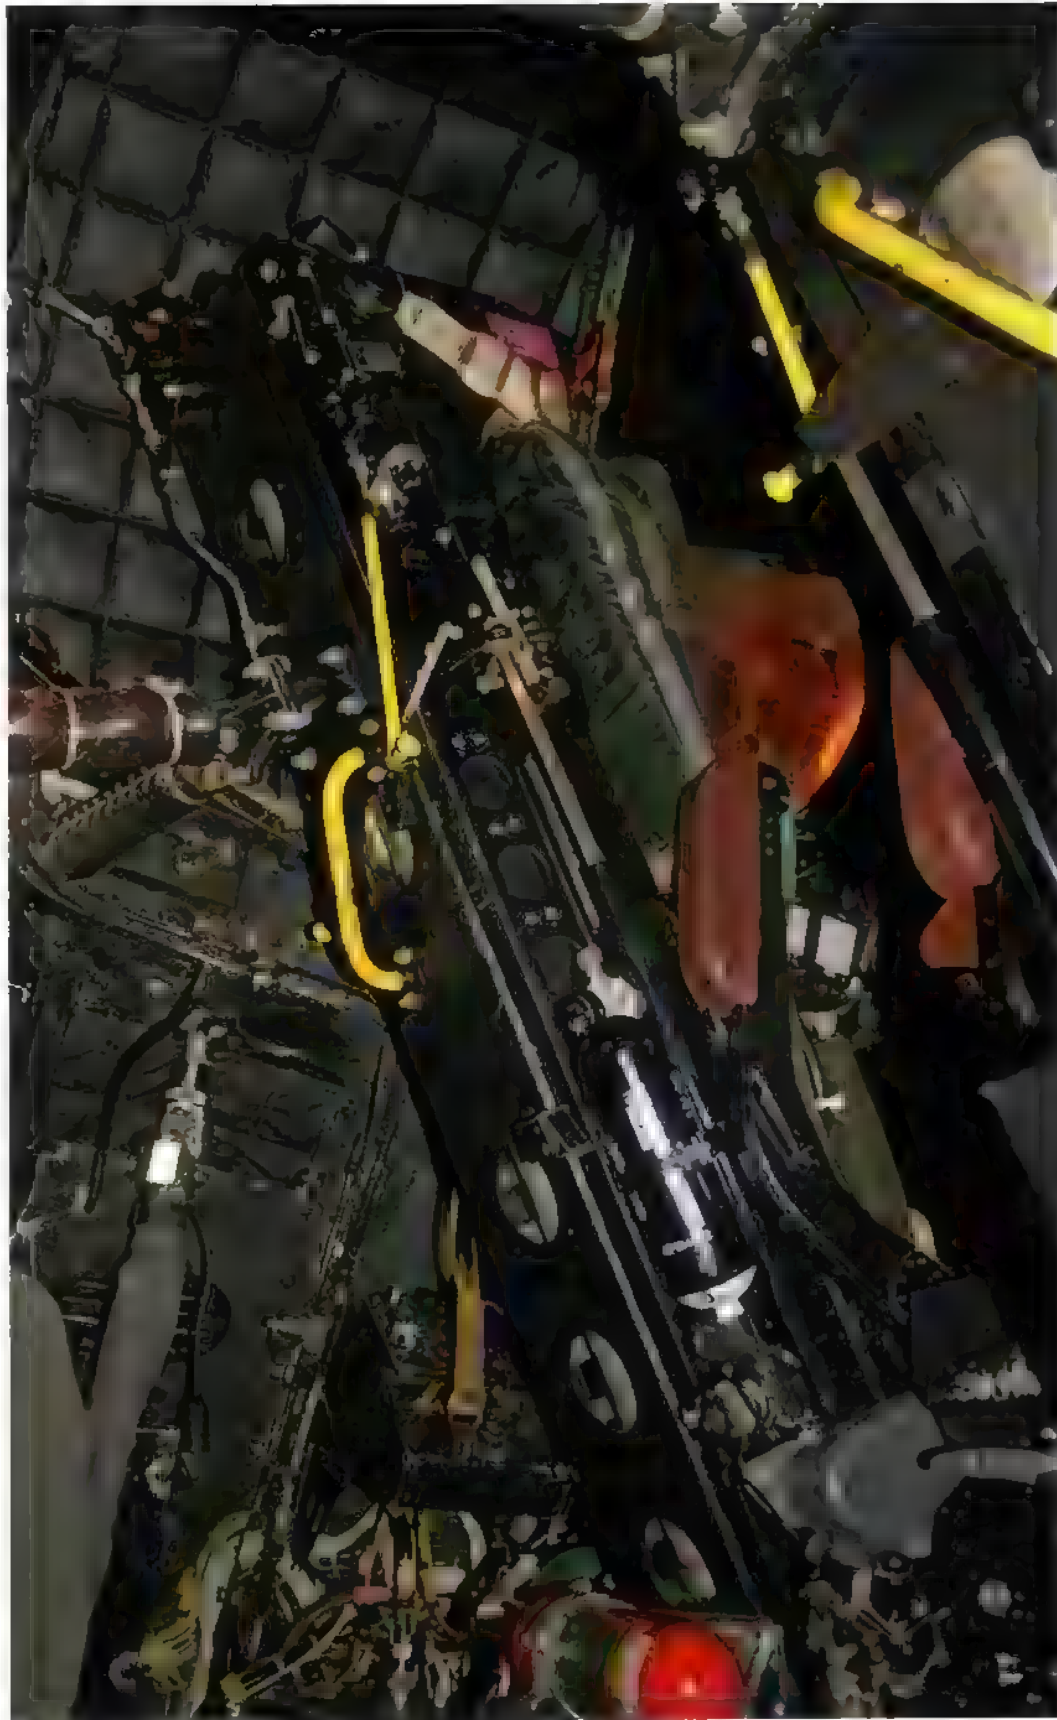
**LEFT** Pilot's ejection seat. *Jonathan Falconer*

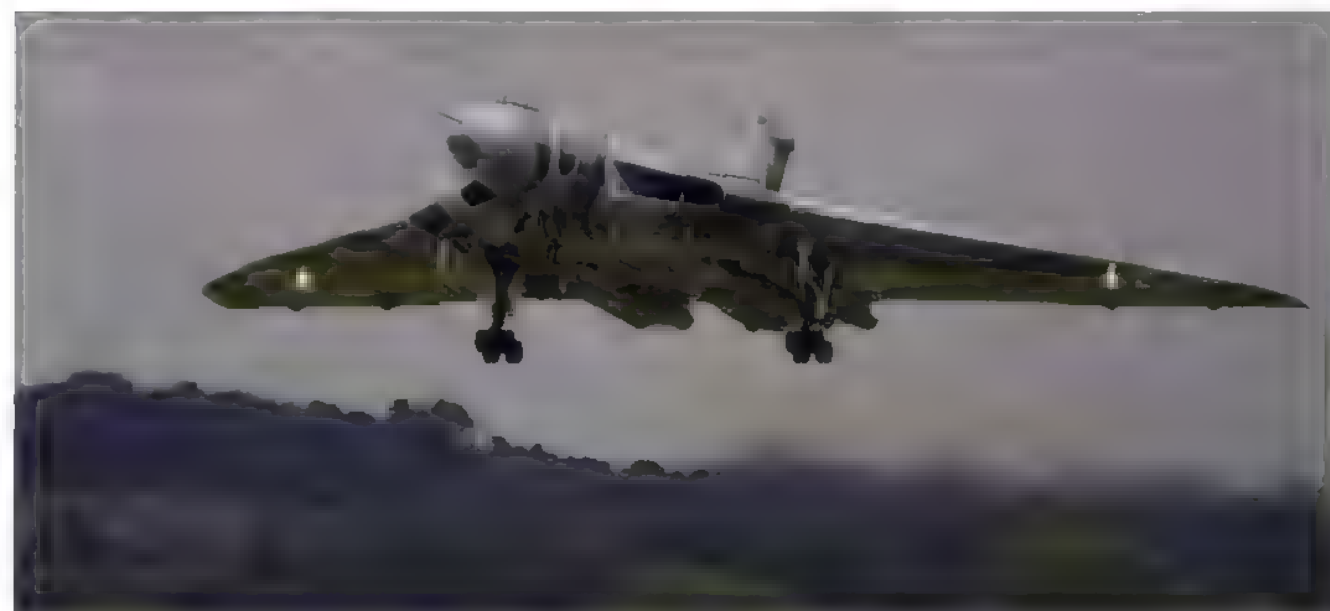
**RIGHT** Air brakes deployed. *Damien Burke*

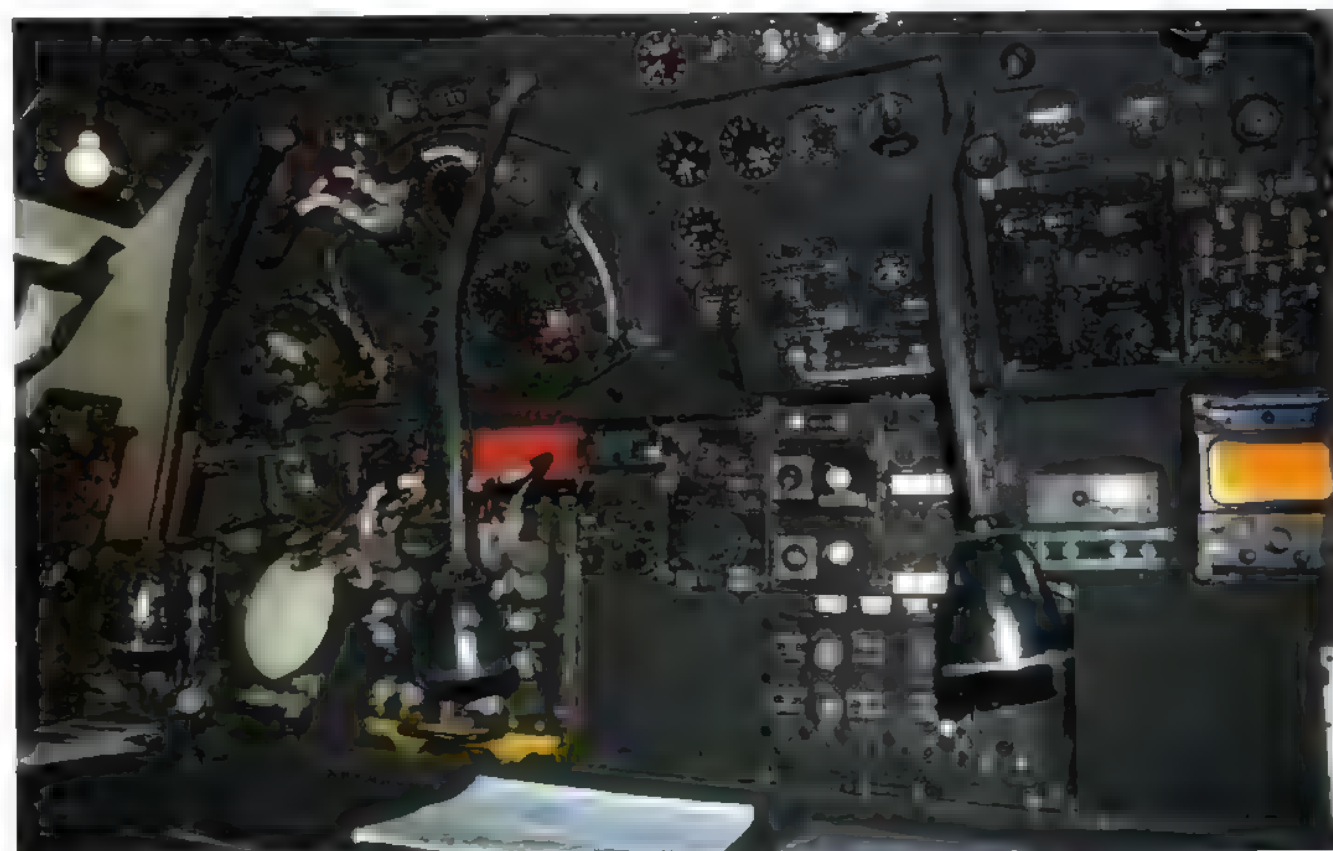
BELOW A general view of the two nav stations. While there was no 'trade demarcation' as such, it is generally true to say that the area on the left of the photo was the Nav Rad's playground, while that on the right was the Nav Plotter's affair, with a bit on the top of mutual interest. The toys on the right were the province of the AEO. *Glen Ambler*

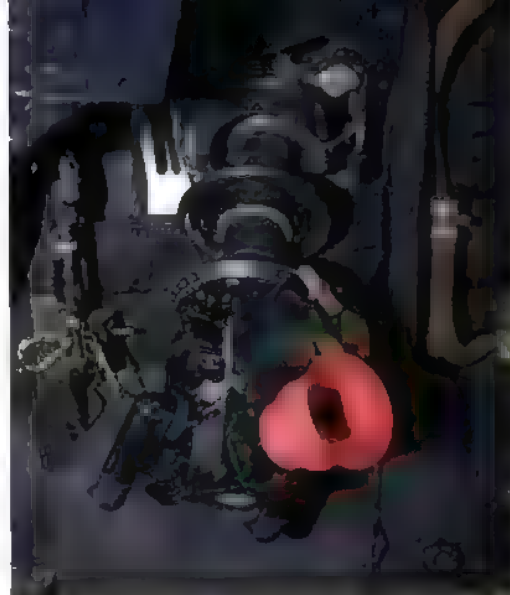
**RIGHT** The periscopic sextant, mounted in the ceiling of the rear crews' position, allowed the Nav Plotter to take readings on celestial bodies.

At distances greater than about 200 miles from land, astro navigation became the primary fixing aid. Astro navigation had definite limitations, especially by day when, as often as not, the only available celestial body was the Sun. And it could furnish only a single position

line. By night, calculating, shooting and plotting a classic two-star, seven-shot fix required at least twenty minutes from start to finish. It was a laborious process, involving numerous arithmetical processes, and any numerical error might negate the whole exercise. Much has been claimed with regard to the accuracy of astro navigation, but much of it has been exaggerated. That is not to say that remarkable results were never achieved; they were. But the overall performance of this method was far less spectacular than the best. For instance, while the final error of the winning crew in the annual Bomber Command Navigation Competition was usually measured in yards, the average accuracy was more conveniently measured in miles – and sometimes quite a lot of them. That said, so long as astro was available you were never 'lost'; but that is not the same as saying that you knew precisely where you were.

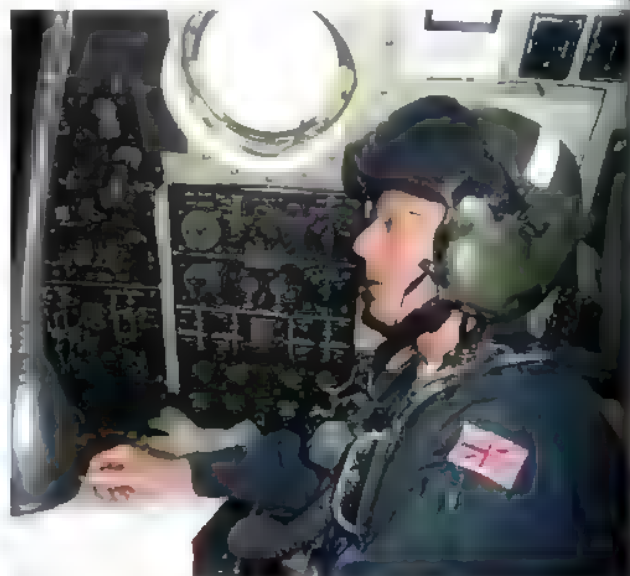
**BELOW** View of the rear crew compartment in XH558, looking towards the AEO's position. Vulcan to the Sky Trust

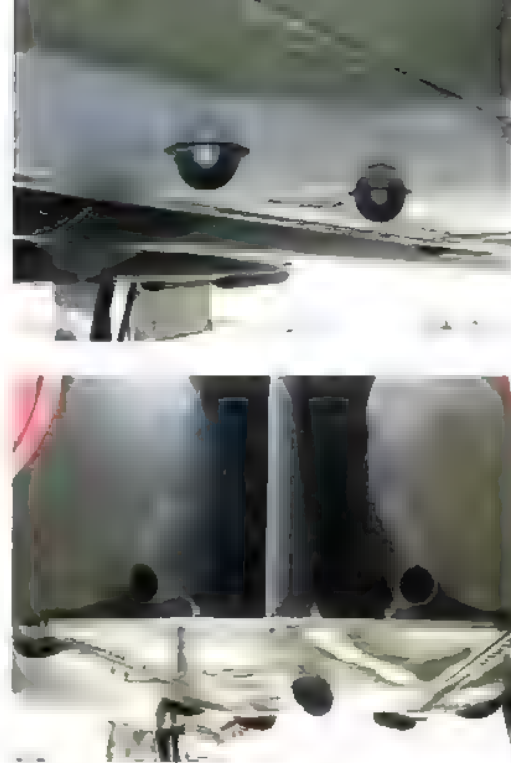
**RIGHT** Two aeri-  
als  
for the Red Shrimp  
jammer, mounted  
under the small  
hemispherical domes  
on an external fairing  
fitted between Nos  
3 and 4 engines.  
*Jonathan Falconer*

- **Red Shrimp** high powered carcinotron noise jammer, three carried, operating in the DE band. The main units were located in the ECM bulge in the tail of the aircraft. These jammers were targeted at the Soviet Fansong (in each case the designations of Soviet equipment are given here by their NATO code names) missile guidance radar, which formed part of the SA-2 surface to air missile system. They also had a capability

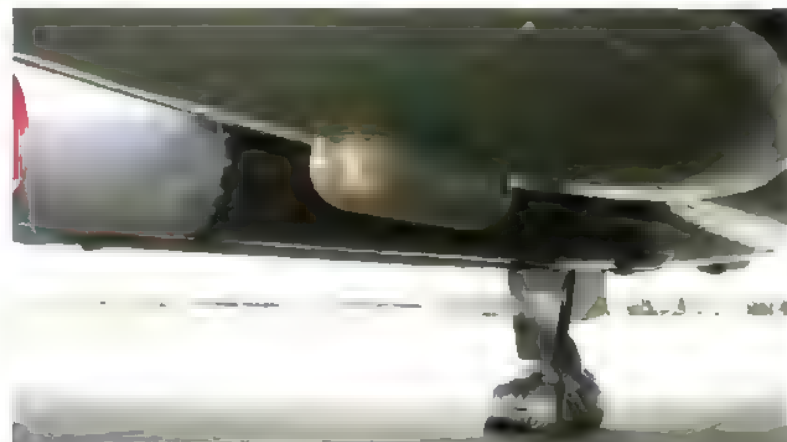
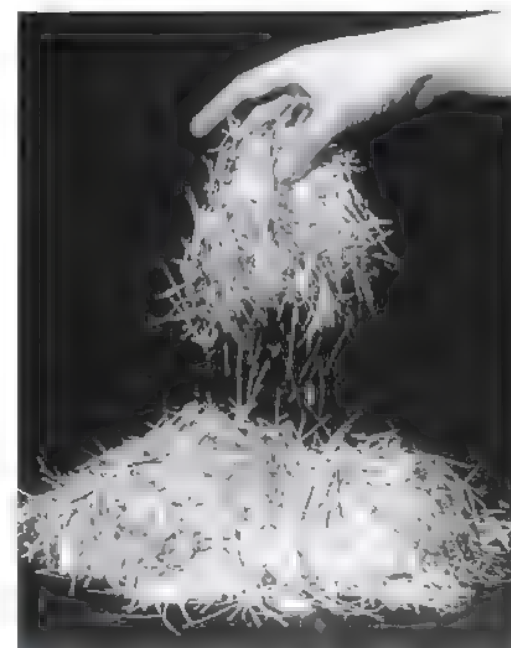
**BELOW AND RIGHT**  
The aerial for the ARI  
18146 I Band radar  
jammer, mounted  
beneath the ECM  
bulge at the rear of  
the aircraft. The AEO  
could switch the  
jamming to the front  
or the rear depending  
on the direction of the  
threat. This equipment  
was introduced into  
service during the  
1970s. *Steve Rendle*

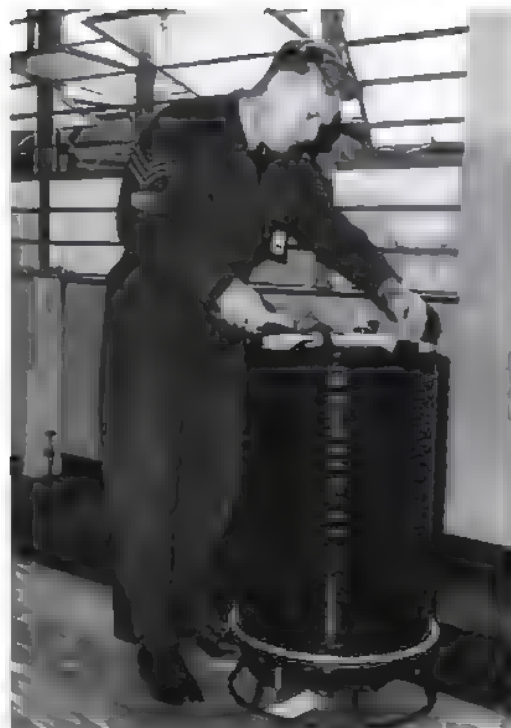
**RIGHT** For operations in the rarefied atmosphere at ultra high altitude, with jammers running at high power for long periods, it was necessary to house them in pressurised drums to prevent arcing. This drum was one of two that housed the main components of a Red Shrimp jammer. *Alfred Price collection*

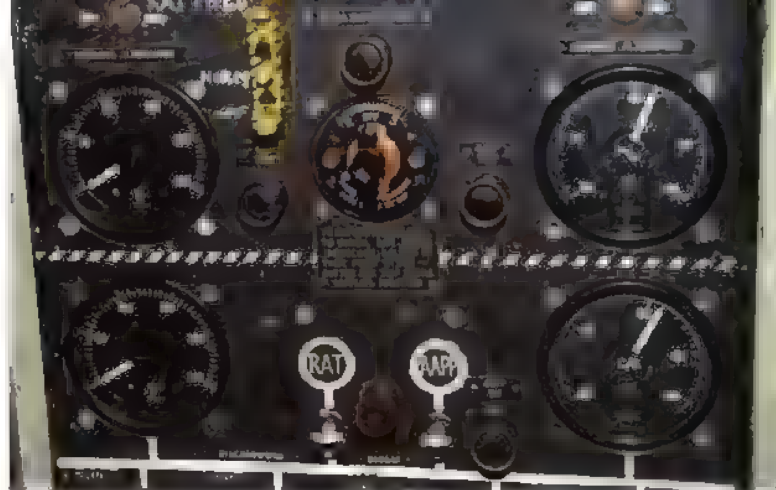
**ABOVE** Close-up view of the main 200v 400 c/s control panel. Phil Whalley

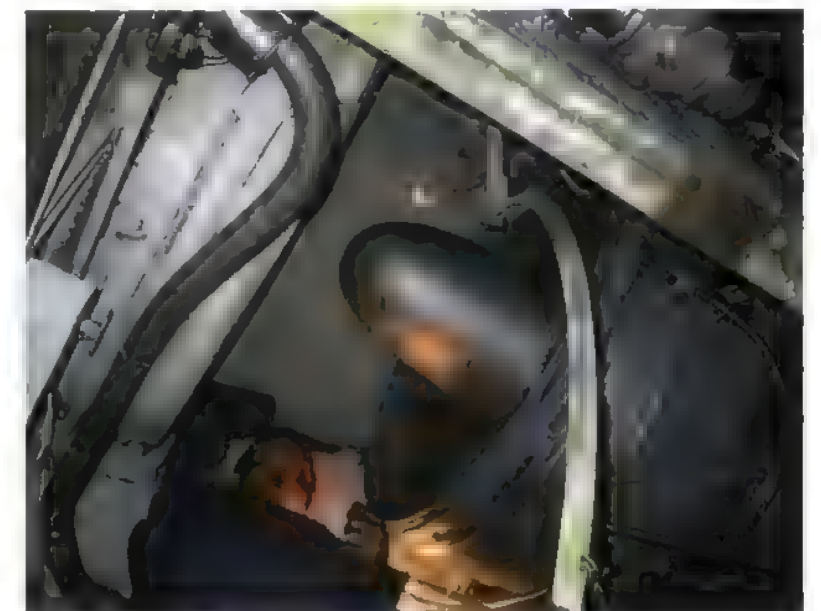
**BELOW** Checking the high energy ignition units at the front of the engine. Vulcan to the Sky Trust

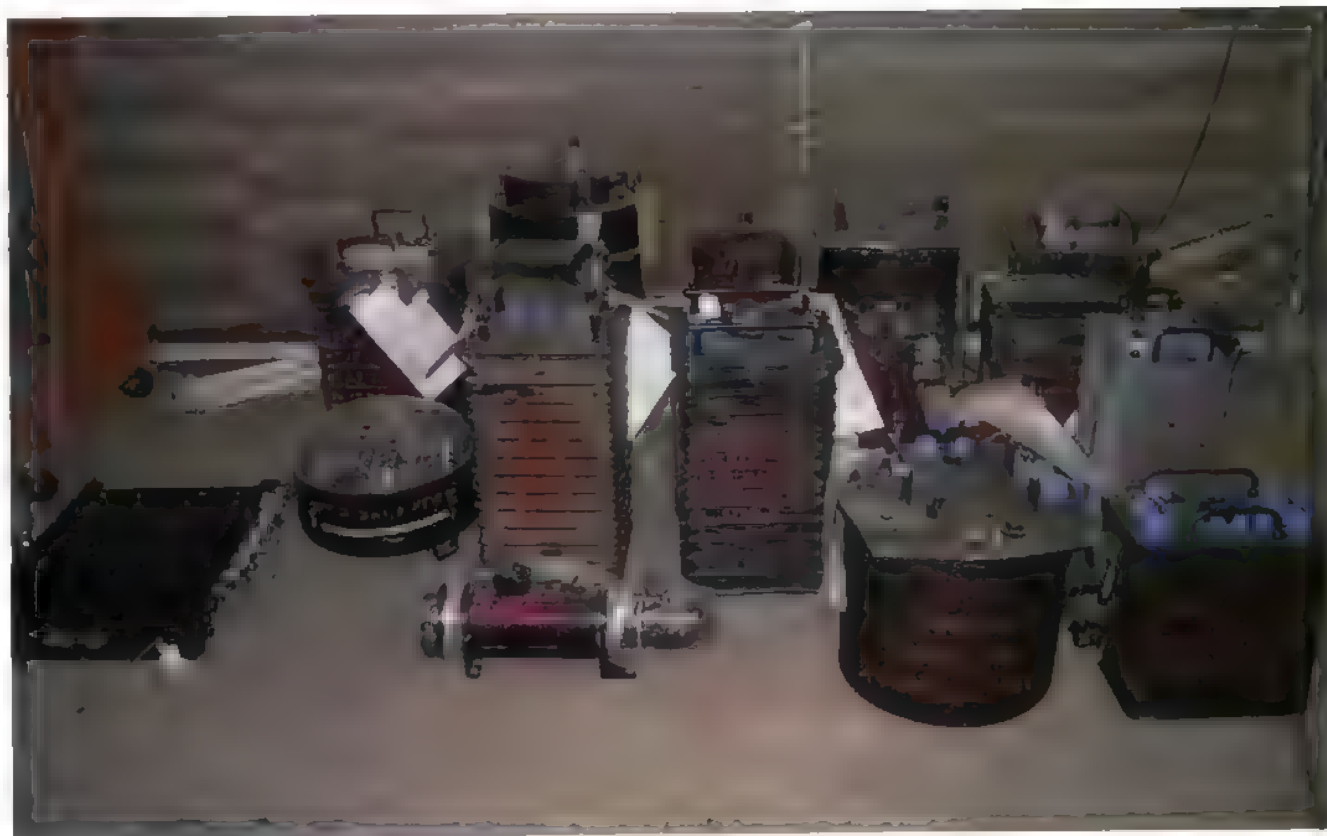
**ABOVE** An array of operational systems removed from XH558. After these had been deactivated, they were returned to their previous positions in the aircraft to serve as ballast.

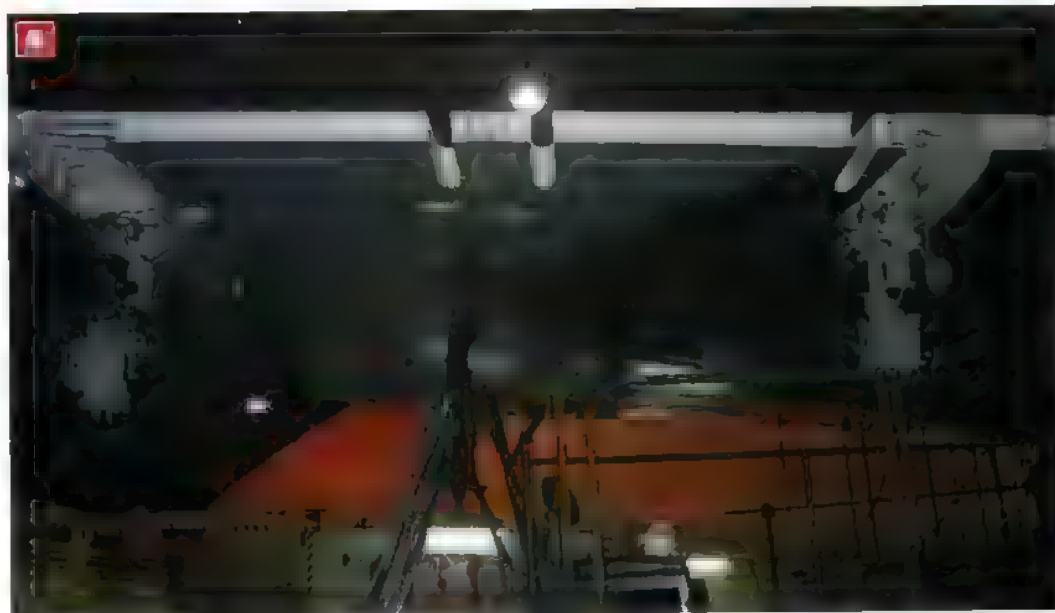
**5** The powered flying control units (PFC units) hang down from their main brackets before they are connected to the elevons.

The elevons, by virtue of their size, are awkward items to move into position on the wings. A specially designed lifting strop is therefore necessary, which fits between the crane hook and the elevon, to support the latter as it is pushed into place. The rudder also has its own specially designed lifting strop, to hold it in the near-vertical position as it is moved into position.

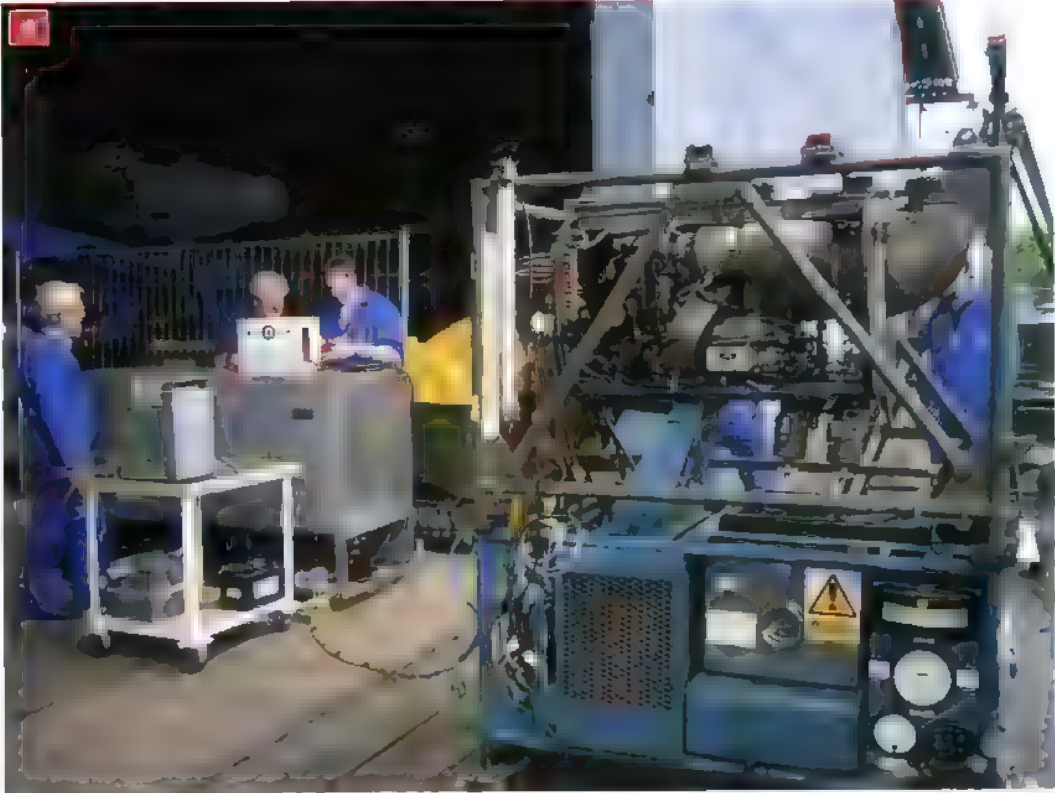
1 In addition to the four Olympus engines the Vulcan B2 carried a fifth engine, the Rover BF Goodrich AAPP. This small turbojet engine produced electrical power for ground or emergency use, as well as compressed air for engine starting. It is seen on the right, mounted upside-down, on top of its special test rig. Malcolm Lawrence is carrying out the test and overhaul. Note that the engine exhaust, on the extreme right, is pointing upwards. Had the exhaust been pointing downwards, it might have lifted the test rig off the ground. The blue-painted items in the picture belong to the test rig; the green tubes are part of the carrying frame for the AAPP.

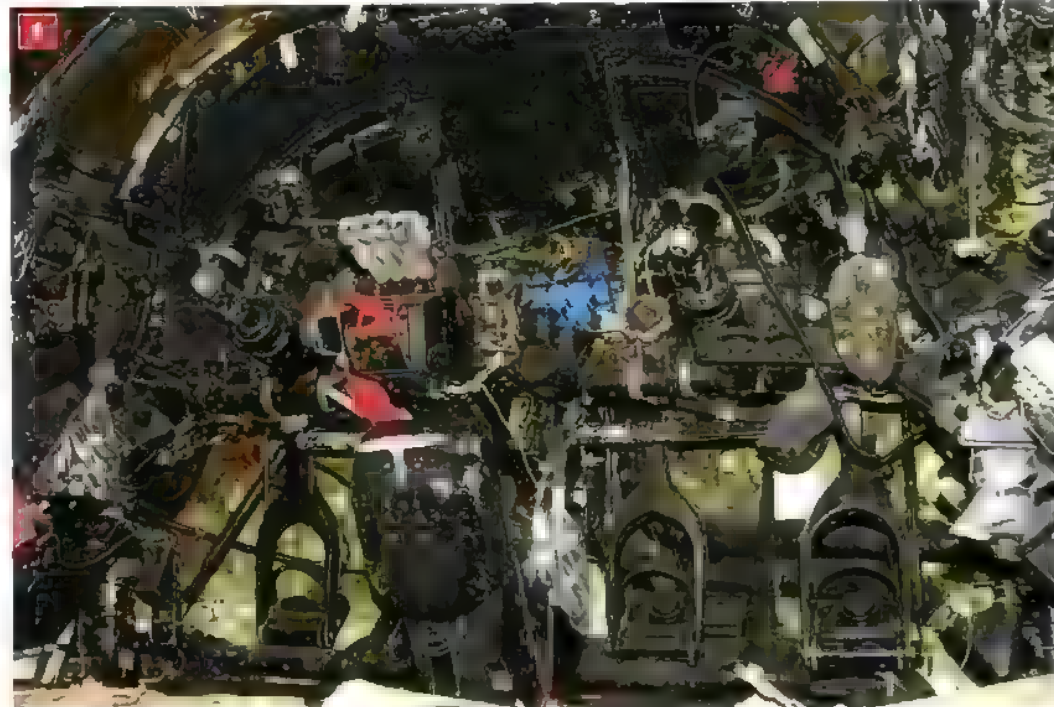
**4** Ron Evans works on the emergency hydraulic power pack. This unit provides not only the hydraulic pressure necessary to open the bomb bay doors, but also to charge the brake accumulators in the event of a failure of the main system.

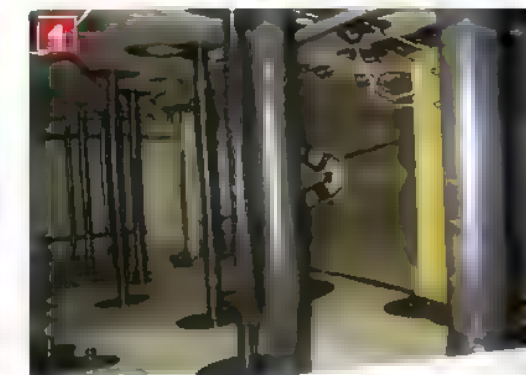
**4** This is a view inside a bag tank fitted in the wing. The vertical cylindrical rods are tie rods that support the bag in the airframe. At the rear are the transponders for the indicators that measure the fuel level in the tank.

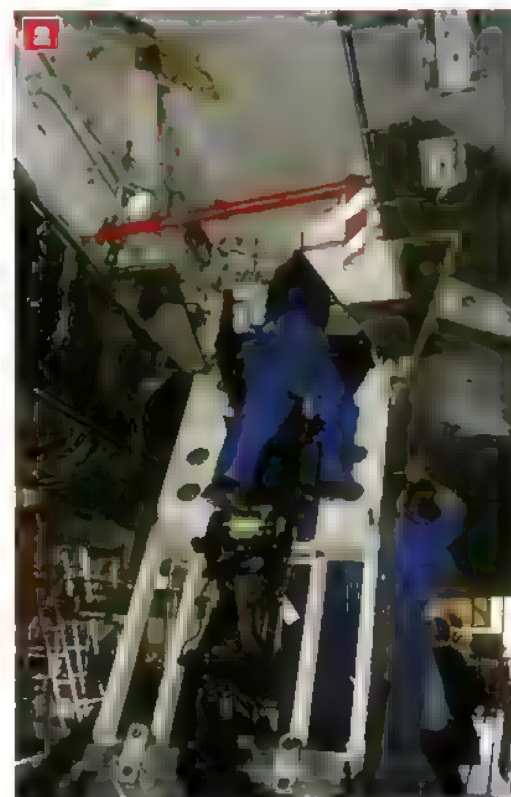
**2** The port undercarriage leg, seen from the rear. The man standing on the staging at the top centre gives an idea of the size of these units. He is working in the engine recuperator bay, where the two recuperators on that side are positioned. The purpose of these units is to force fuel up to the engines to allow them to continue to run when the aircraft is flying at zero or negative G. Such flying is not permitted in peace time, but it might have been forced on the crew in time of war.

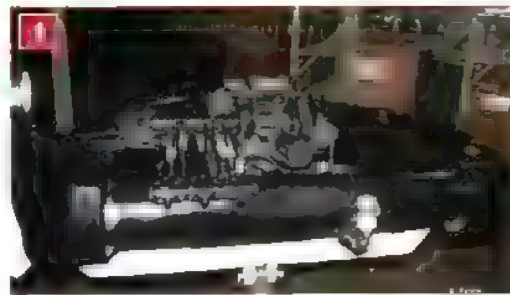
**1** Looking down at a main undercarriage leg. The walking joints are on the left and the locking mechanism on the centre. *D. Petre*

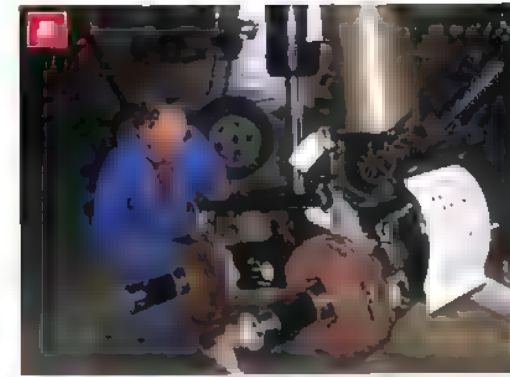
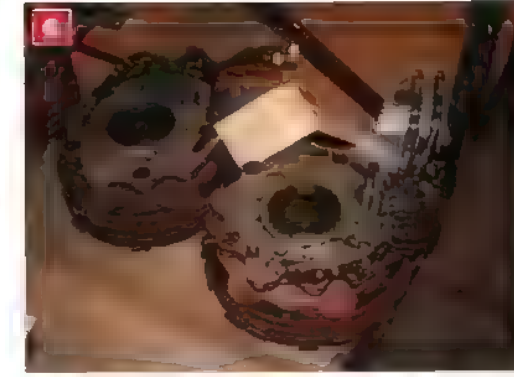
**C**lose-up shots of the main undercarriage leg and the 'Maxaret' anti-skid brake unit. Each of the eight wheels on each main wheel bogie has to be inflated to a pressure of 275lbs/sq in.

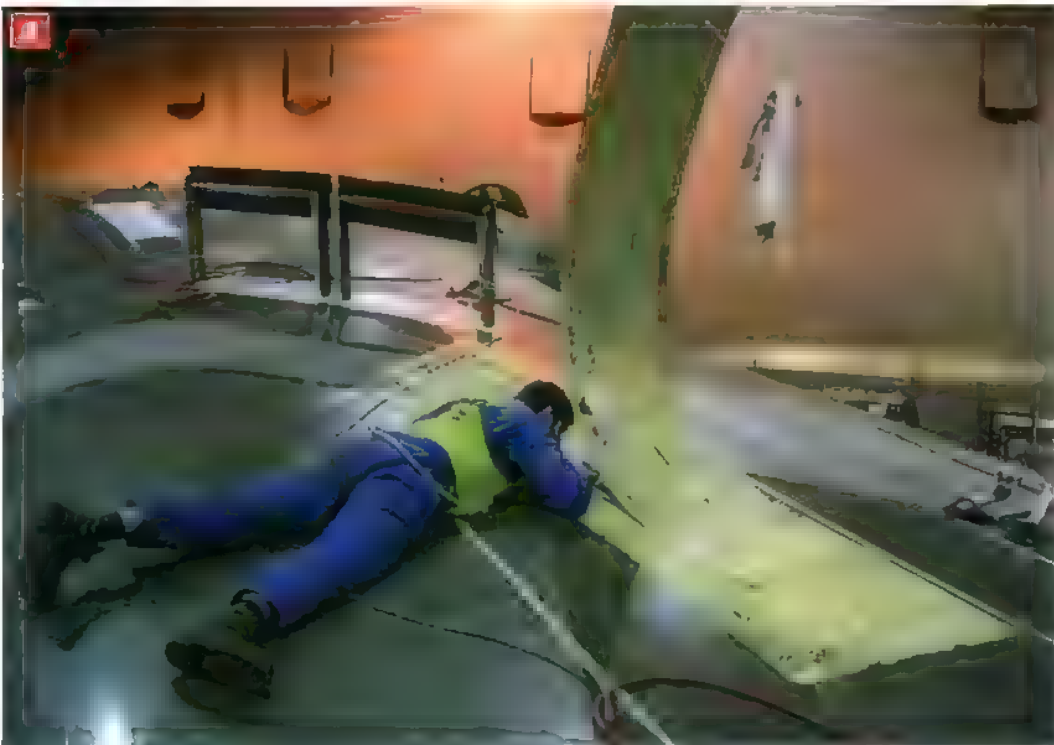
**1** Corrosion was found in the underside roof of the main undercarriage bay. The 'J' section beams, which were badly corroded, had to be removed by grinding in the less affected areas, or by complete replacement of the beams.

**2 and 3** In order to repair an area of corrosion found in the starboard wing it was first necessary to peel back the outer skin on the top surface. Then the corroded 'J' and 'Z' section structures could be removed and replaced. Here Trevor Bailey can be seen working on an affected area inside the starboard wing.

Since the bruising battle to bring corrosion under control in 2006, the technicians have been very sensitive about this condition. As a precaution, if the aircraft is caught in a rain storm or if it has been left in the open for more than two weeks, they conduct a further deep inspection of the airframe, searching for any sign of a recurrence. So far – touch wood – there has been none.
